Your Inspection Report

2 Appletree Lane
Red Deer, AB T4R 3H1

INSPECTION DATE:
Monday, December 5, 2022

RE: Report No. 1004, v.3
2 Appletree Lane
Red Deer, AB
T4R 3H1

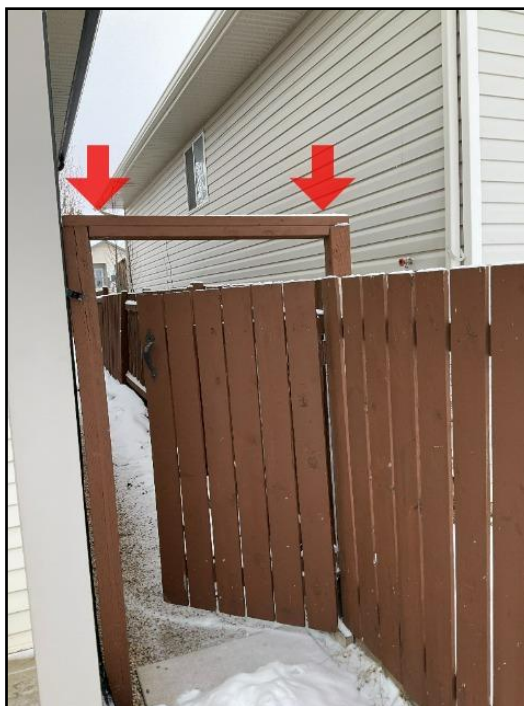
1. Condition: • Safety concern. This gate frame needs to be corrected as tall individuals will hit their heads on this beam.

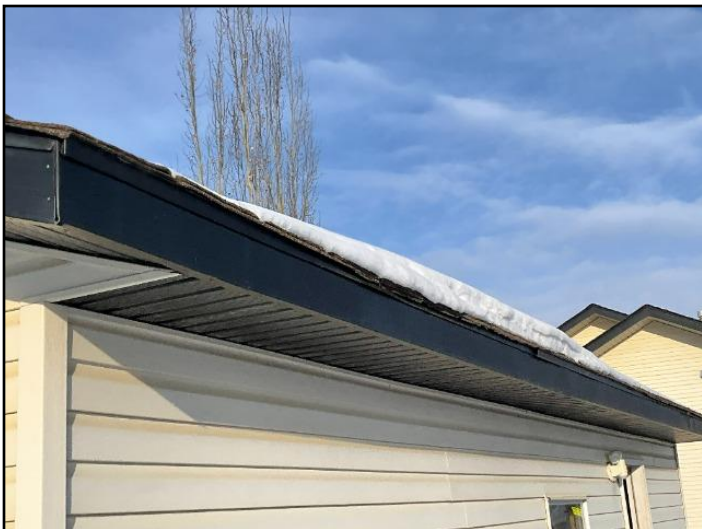
2. Missing

The detached garage did not have eavestroughs or downspouts. The absence of these can lead to premature deterioration of the foundation of the garage. Recommend to hire a suitable contractor to correct.

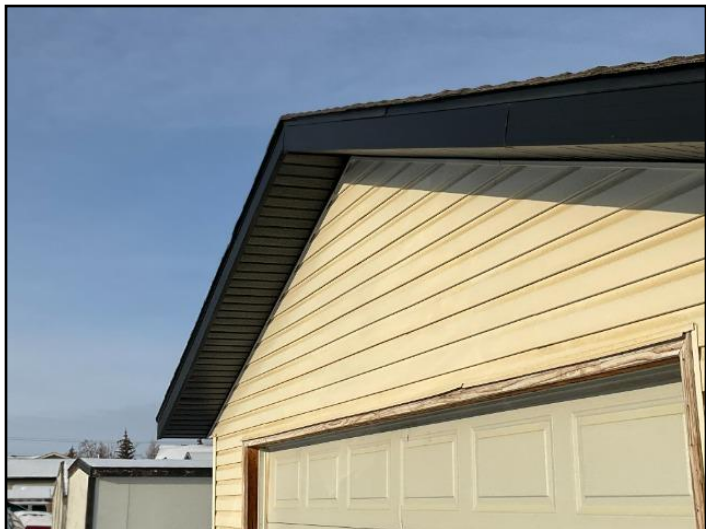
3. Missing

The discharge locations of all eavestroughs on the west side of the house need to be corrected as they are discharge within four feet of the foundation.

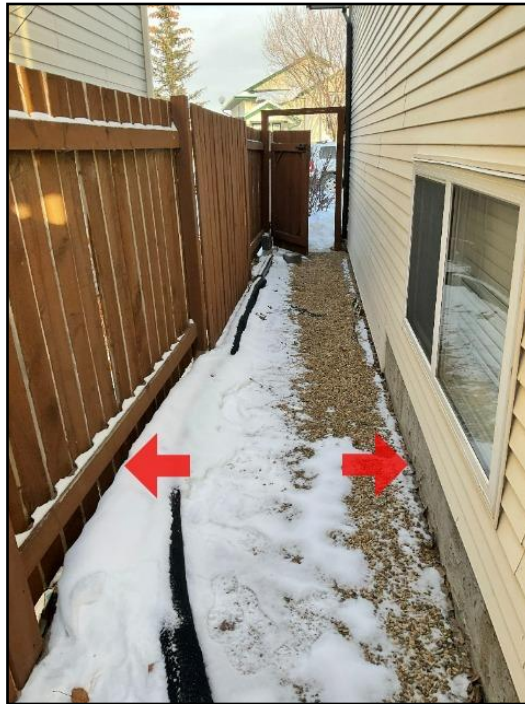
4. Discharge too close to building

The discharge point could not be determined during the inspection. It is recommended that this be reviewed when visibility can be improved. The downspout should not discharge within four feet of the foundation to prevent damage to the foundation.

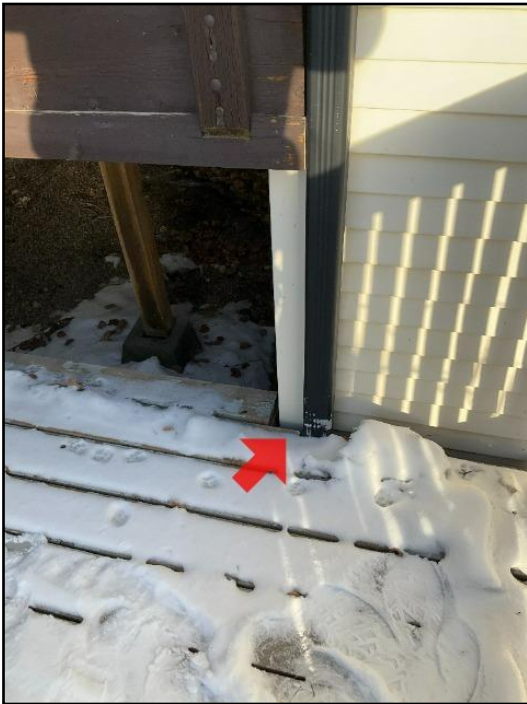
5. Discharge below grade

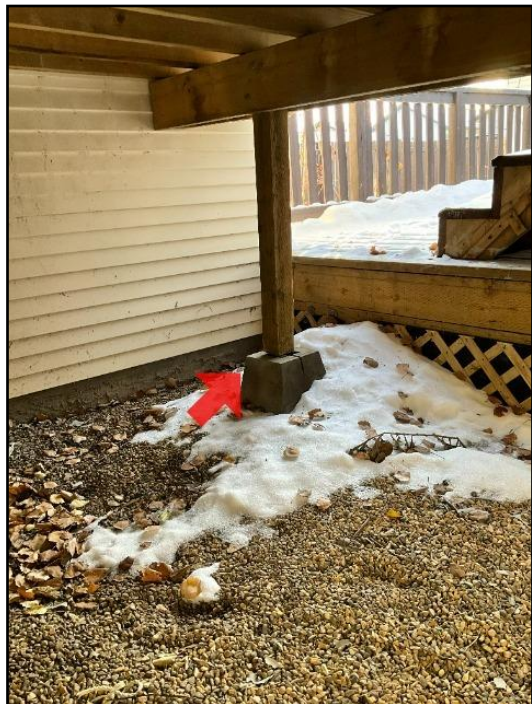
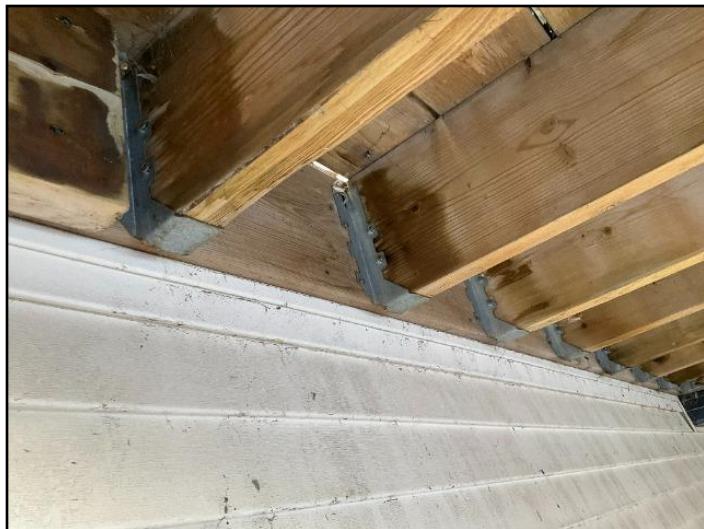
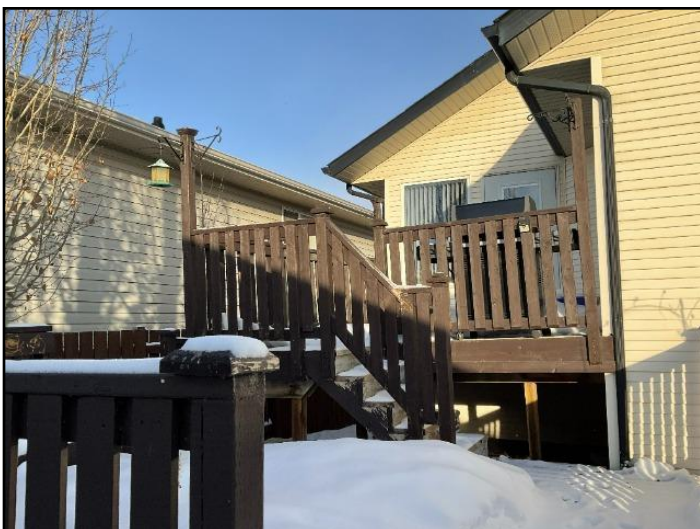
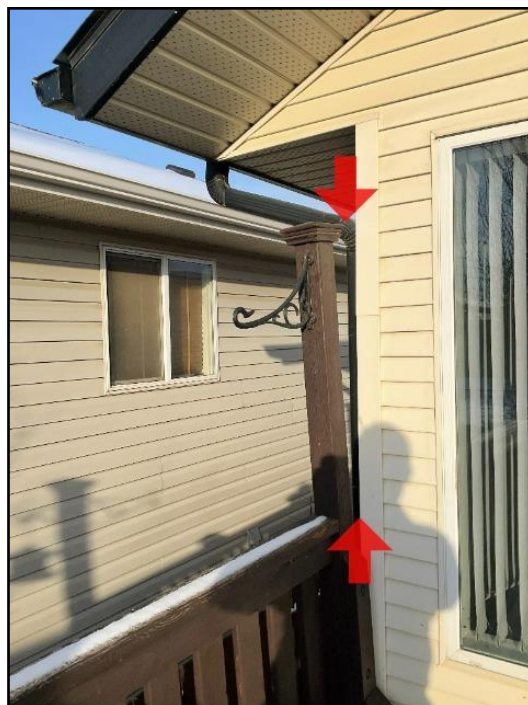
The upper deck area of the rear deck is in immediate need of repair and should not be used until this is completed. One of the support columns is no longer supported within it's footing, the deck joists should be attached to the house with lag bolts, not screws and brackets; and the deck is twisting which is likely caused from the at grade footings which should be below the frost line. It is recommended that a qualified contractor be contacted as soon as practical to assess and carry out the required repairs before any further use.

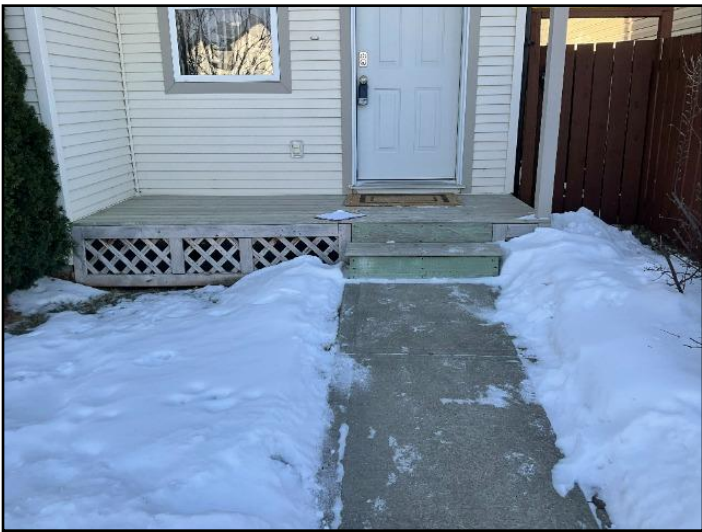
10. Missing

For safety, it is recommended to add handrails to the front steps and to the porch area.

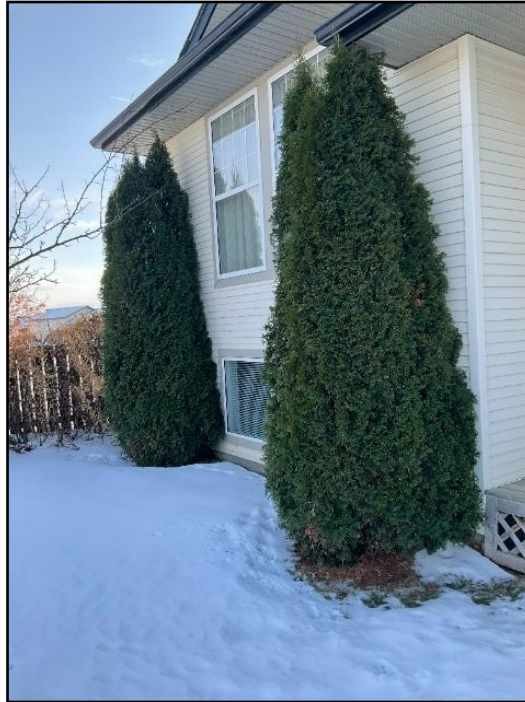
Shrubs/bushes are in contact with the front of the home. To prevent damage to the siding and water intrusion to the basement it is recommend that these be pruned back or removed.

11. *Trees or shrubs too close to building*

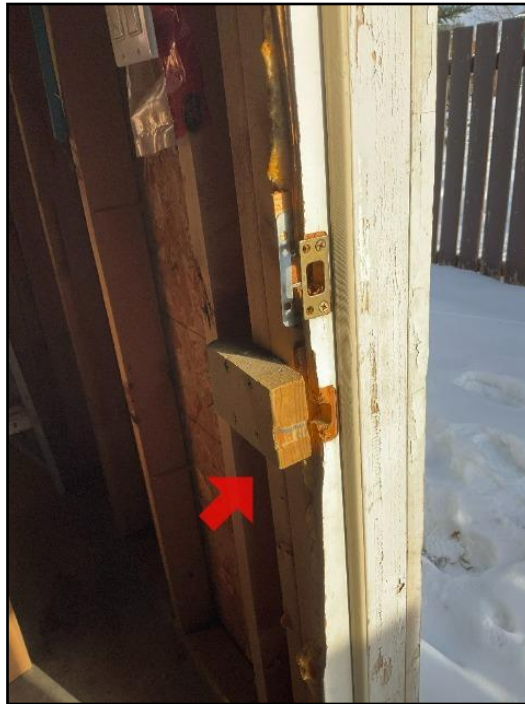
12.

8. Condition: • The garage entry walk-in door handle and lock were damaged. Recommend repair.

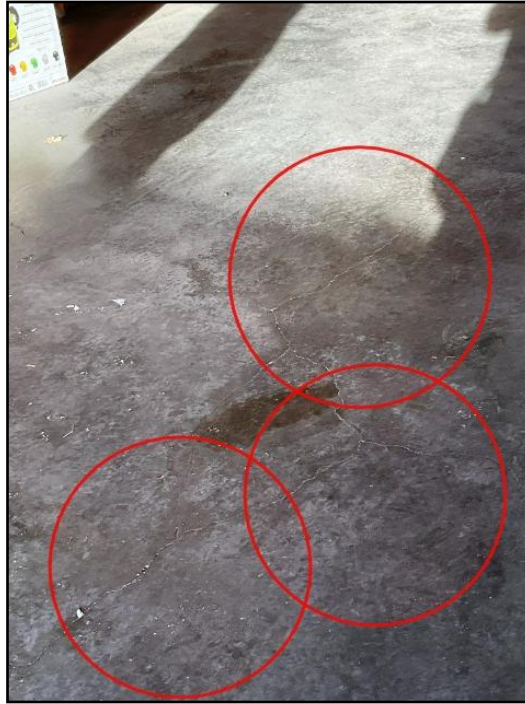
The garage floor had cracking on it. The cause is unknown but possibly from the poor drainage of the roof. It is recommend to correct the roof drainage and monitor the garage floor degree of cracking.

13. Cracked

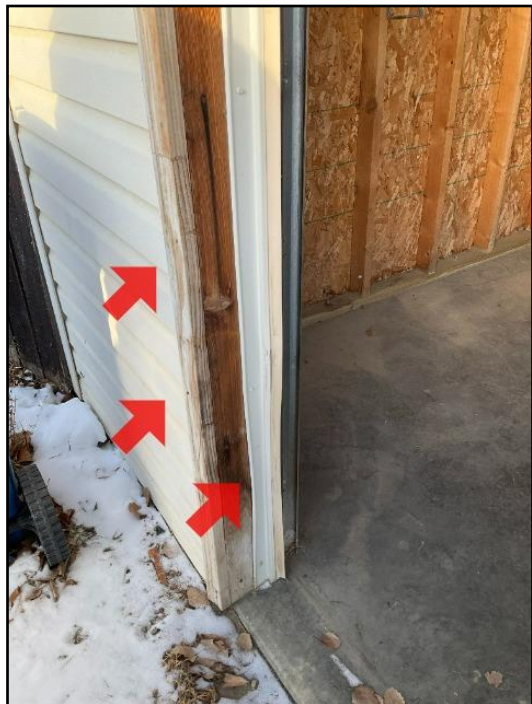
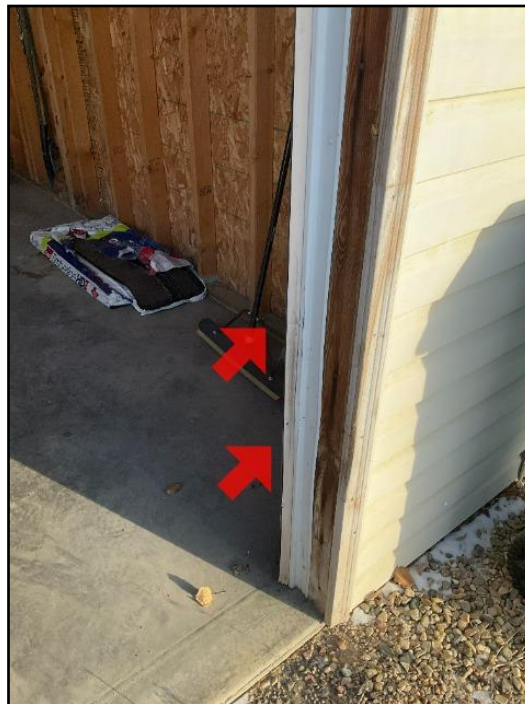
10. Condition: • Dented

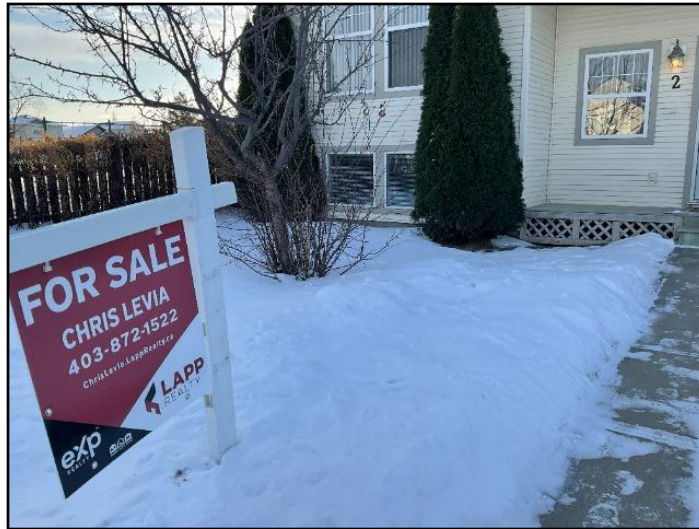
Yard drainage was not able to be inspected due to snow cover. Recommend that this be completed when visibility is improved.

16. Snow / ice / frost

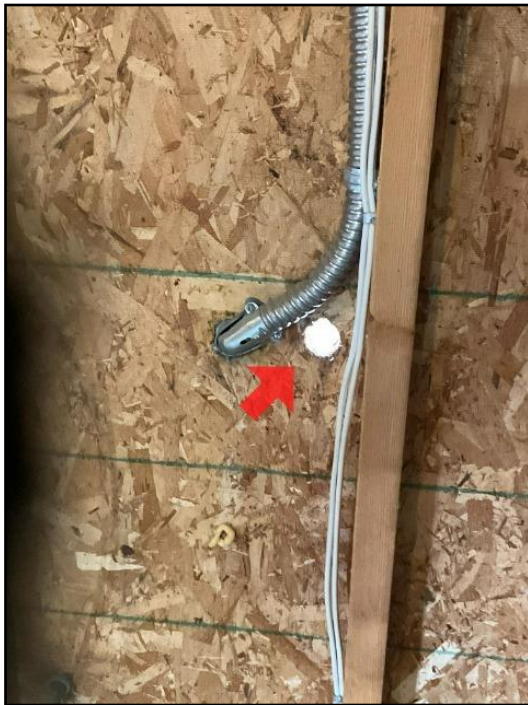
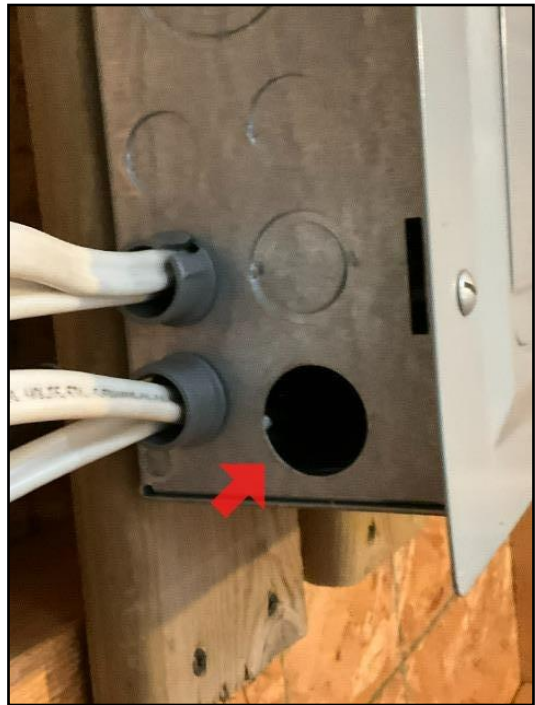
13. Condition: • The auxiliary panel had a missing knockout which should be corrected. Further, in close proximity to this there is a hole in the garage wall that can potentially allow mice inside; leading to damage of the wiring and the inside of the panel.

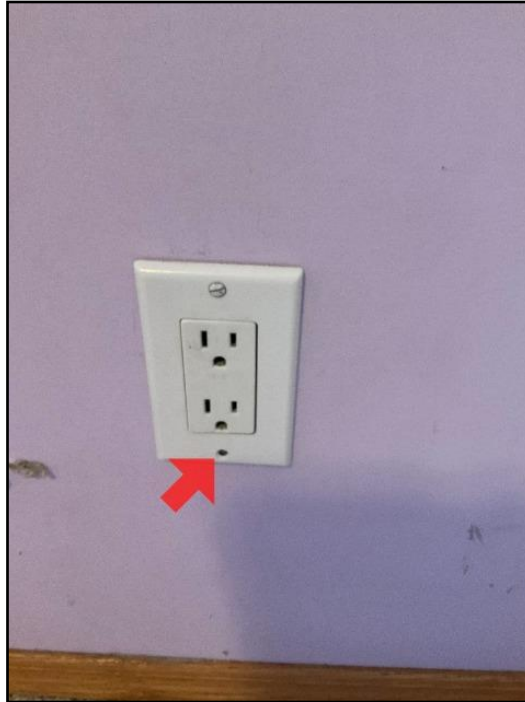
One of the outlets in the master bedroom was missing a screw and was loose. Recommend repair as soon as practical for safety.

24. Loose

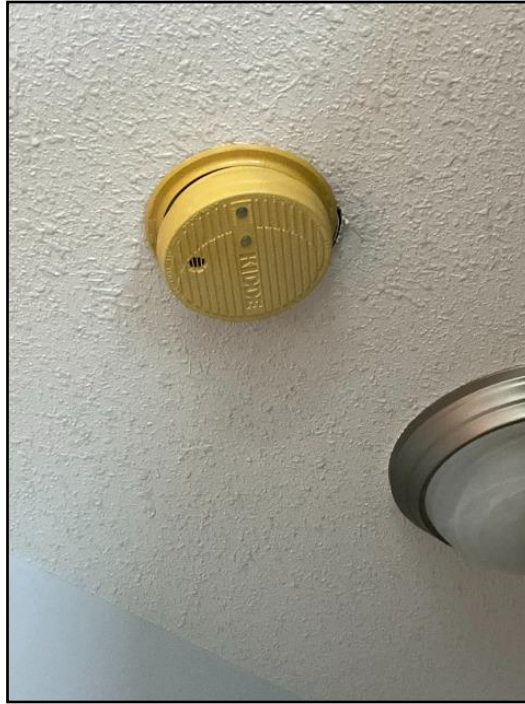
The smoke detector on the main floor near the kitchen area appeared to be very old. Recommend that this be upgraded.

25. Old

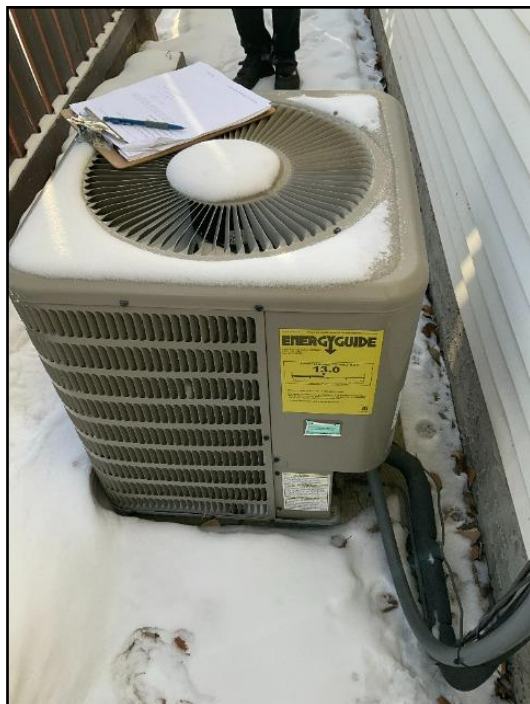
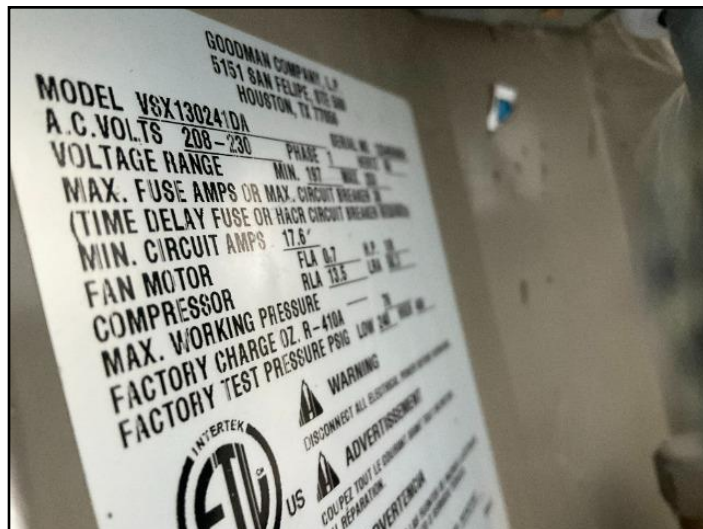
Was not able to determine the age of the Goodman Company air conditioner from the ID photo that was taken during the inspection. It appears to be a fairly old system and recommend servicing.

19. Condition: • Recommend the unit be covered during the seasons it's not in use to prevent rusting and weathering. Was not able to determine it's age but the unit is old and recommend servicing as part of regular maintenance.

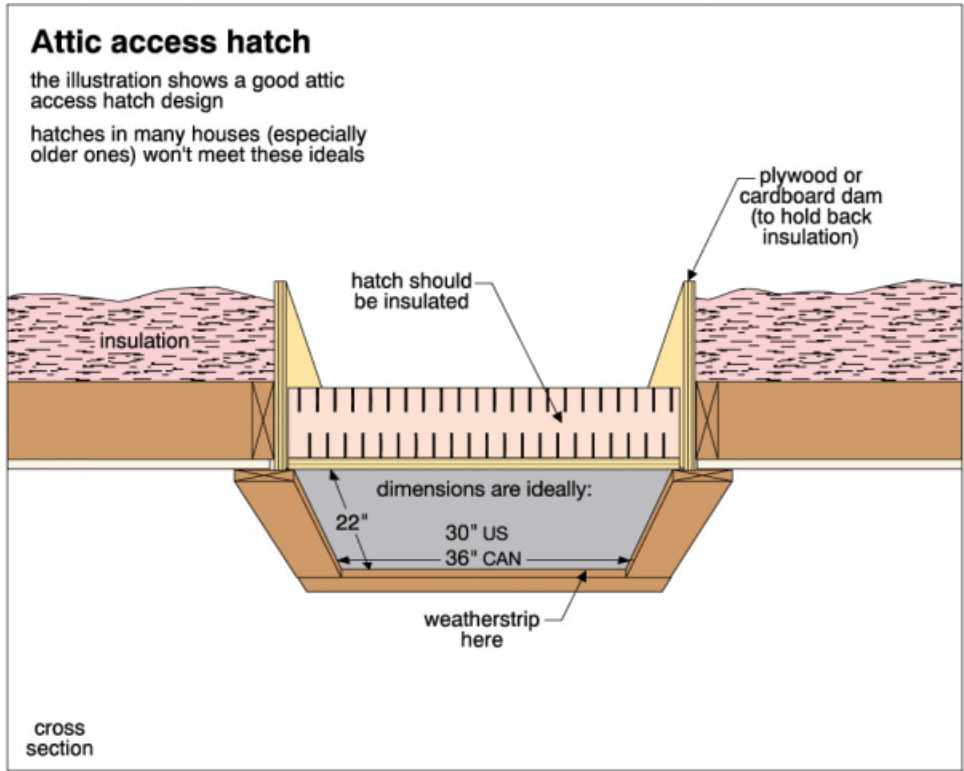
20. Condition: • [Not insulated and not weatherstripped](#)

Recommend weatherstripping on the attic access hatch to improve heating.

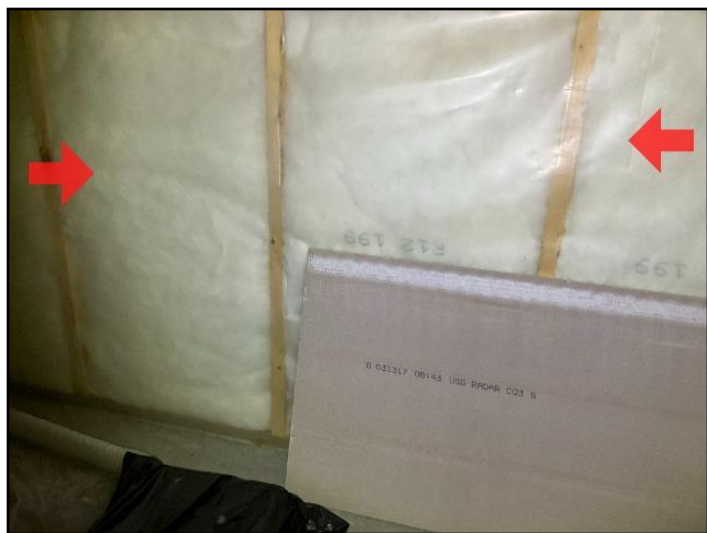
32.

21. Condition: • Recommend installation of drywall in the basement storage area and furnace room to protect insulation and vapor barrier from damage.

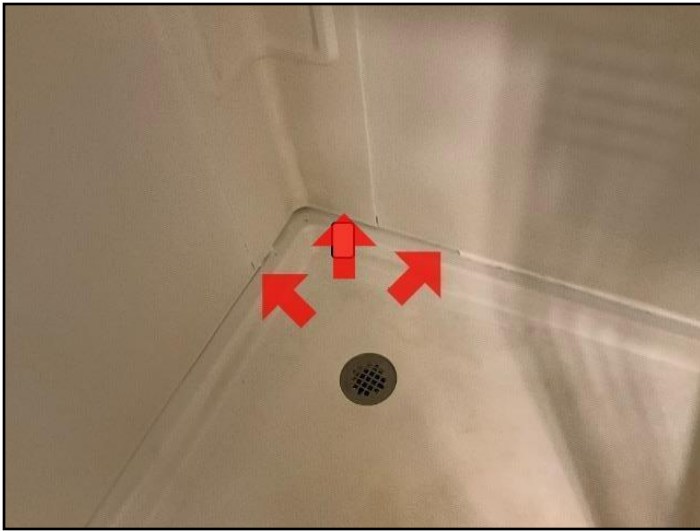
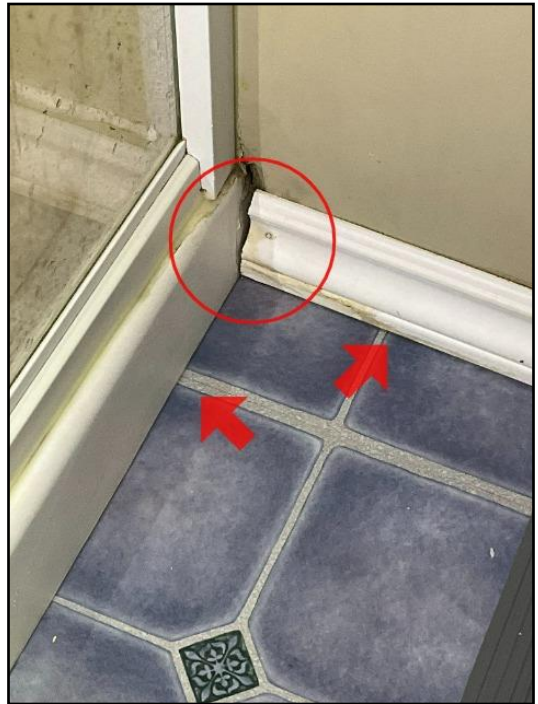
23. Condition: • Evidence of an active leak when the shower was inspected. The shower stall was missing caulking. Recommend that a qualified plumber repair. There may be concealed issues (mold, leaking) behind the wall.

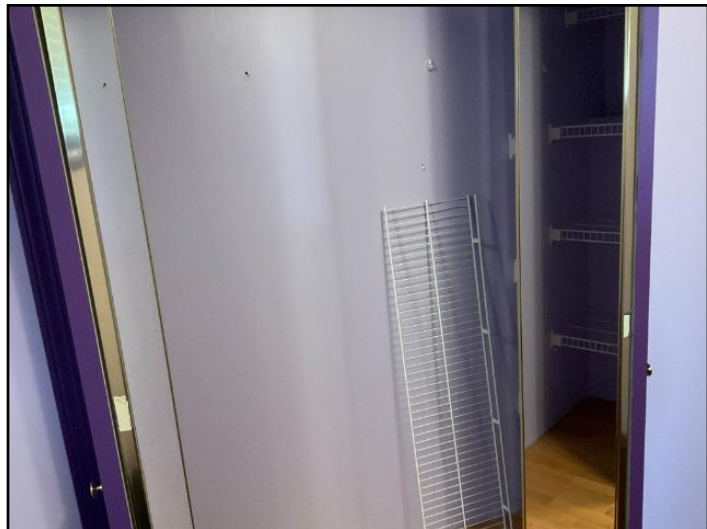
37.

24. Condition: • Closet shelving should be repaired for future use.
Location: West Basement Bedroom
Task: Repair

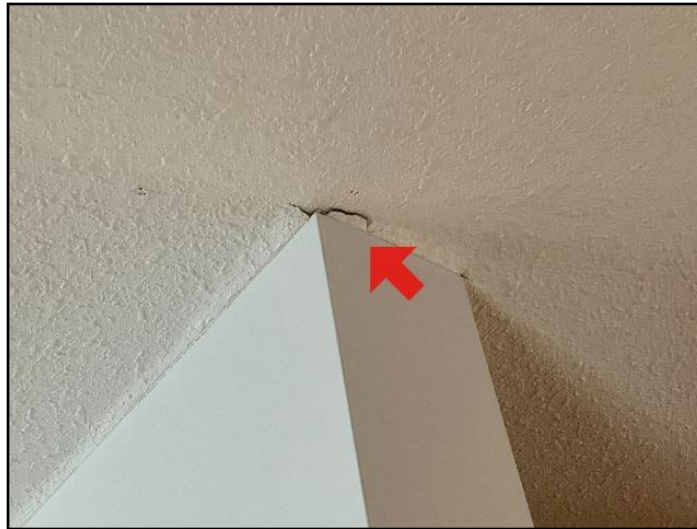
38.

25. Condition: • Damage to ceiling stucco in the kitchen / living room area. Recommend repair.
Location: First Floor Living Room Kitchen
Task: Repair
Time: Regular maintenance

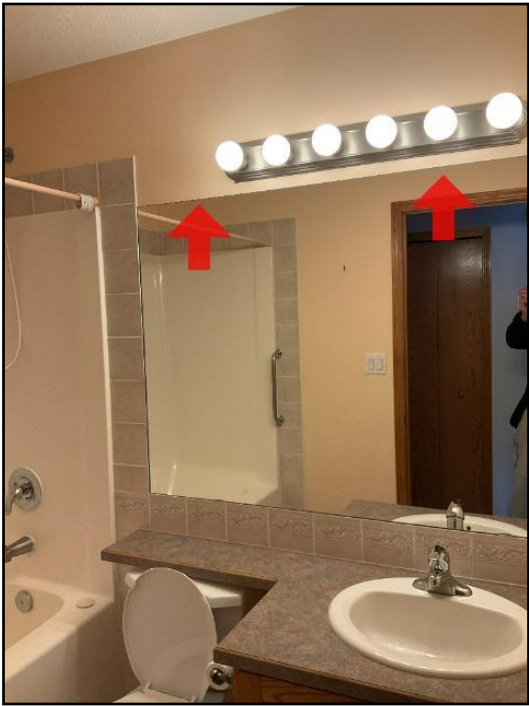
39.

27. Condition: • For safety, it is recommended that upper clips be added to the bathroom mirrors. The clips were only present on the bottom of the mirrors.

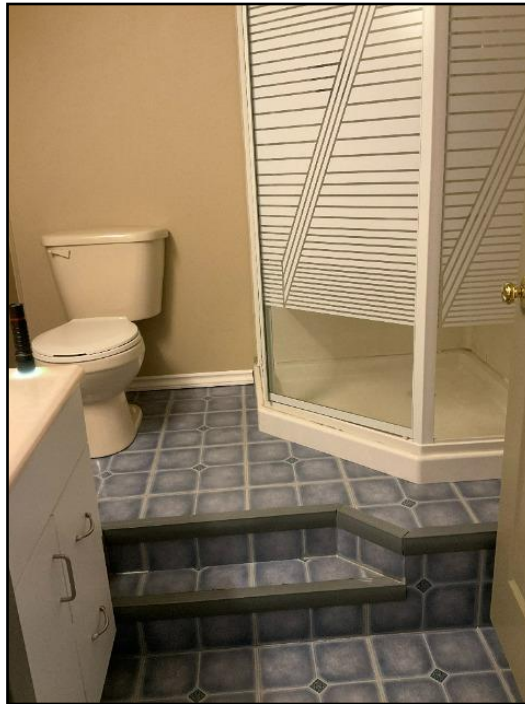
The basement bathroom had an unconventional step-up to the toilet and shower. This is a safety issue, in particular, when exiting the shower. Recommend that a suitable contractor be hired to assess and make recommendations to improve.

40. Trip hazard

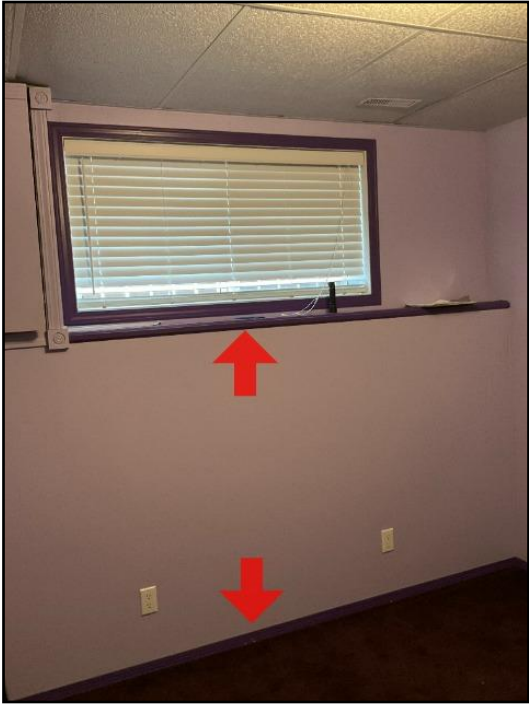
42.

31. Condition: • Windows in both basement bedrooms were too high, approximately 5 feet, for many people to allow for emergency escape. For safety, I recommend that a bed or chair be placed in proximity to these to allow for this.
