Your Inspection Report

2 Appletree Lane
Red Deer, AB T4R 3H1

INSPECTION DATE:
Monday, December 5, 2022

RE: Report No. 1004, v.3
2 Appletree Lane
Red Deer, AB
T4R 3H1

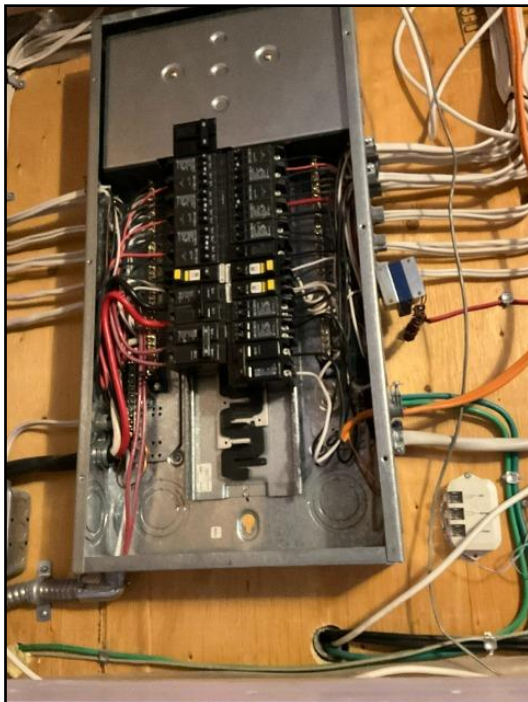
17. 100 Amps (240 Volts)

The distribution panel was located in the west basement bedroom.

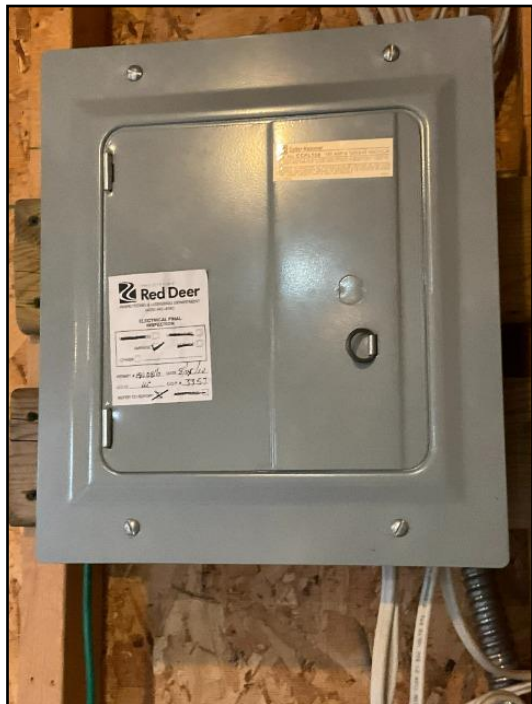
19. Breakers - garage

Condition: • The auxiliary panel had a missing knockout which should be corrected. Further, in close proximity to this there is a hole in the garage wall that can potentially allow mice inside; leading to damage of the wiring and the inside of the panel.

Task: Repair

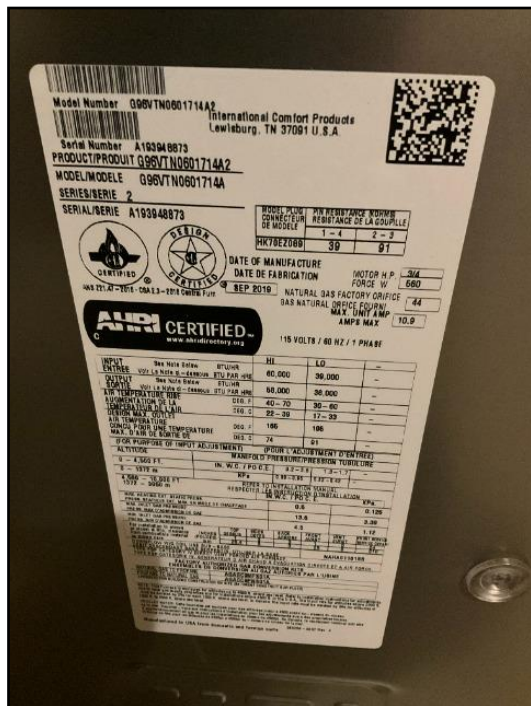
27. Furnace

Furnace is a International Comfort Products brand high efficiency system.

Model number: 696VTN0601714A Serial number: A193948873

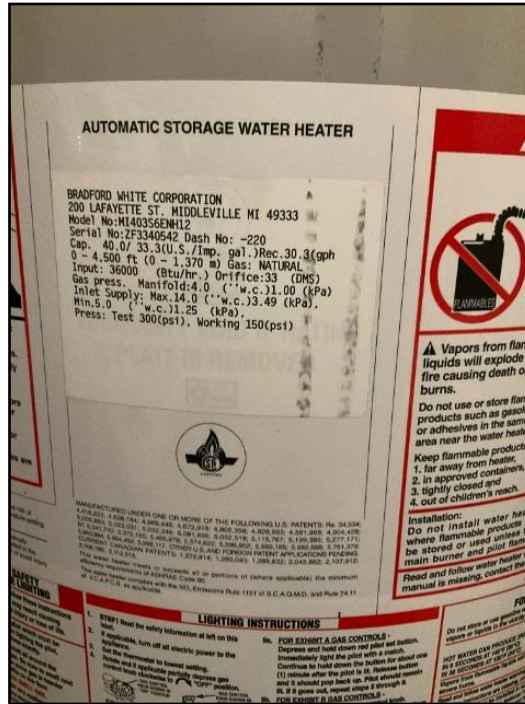
34. 40 gallons

Manufactured: 2003

Model number: MI403S6ENH12 Serial number: ZF3340542

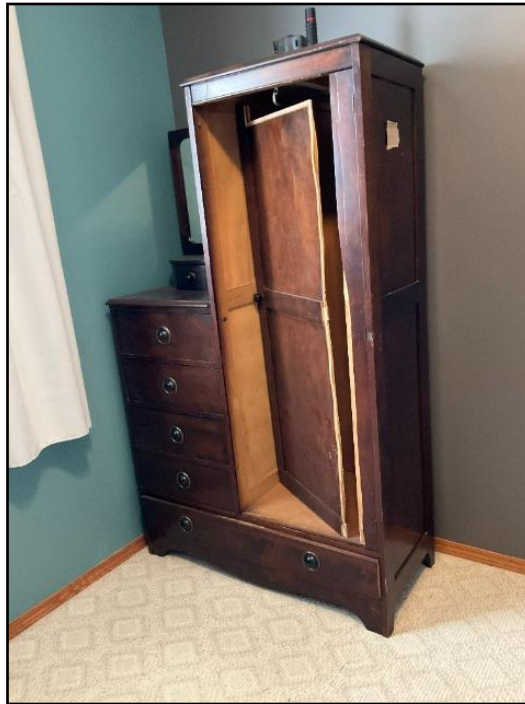
43. Storage/furnishings

- Storage/furnishings
- Furniture in second main floor bedroom prevented inspection of some wall and carpeting areas. There may be issues behind and underneath the furniture that were not able to be observed.
